THE DOME OF THE ROCK IN JERUSALEM

A Description of its Structure & Decoration

ERNEST TATHAM RICHMOND

FELLOW OF THE ROYAL INSTITUTE OF BRITISH ARCHITECTS
CONSULTING ARCHITECT TO THE NOBLE SANCTUARY IN JERUSALEM

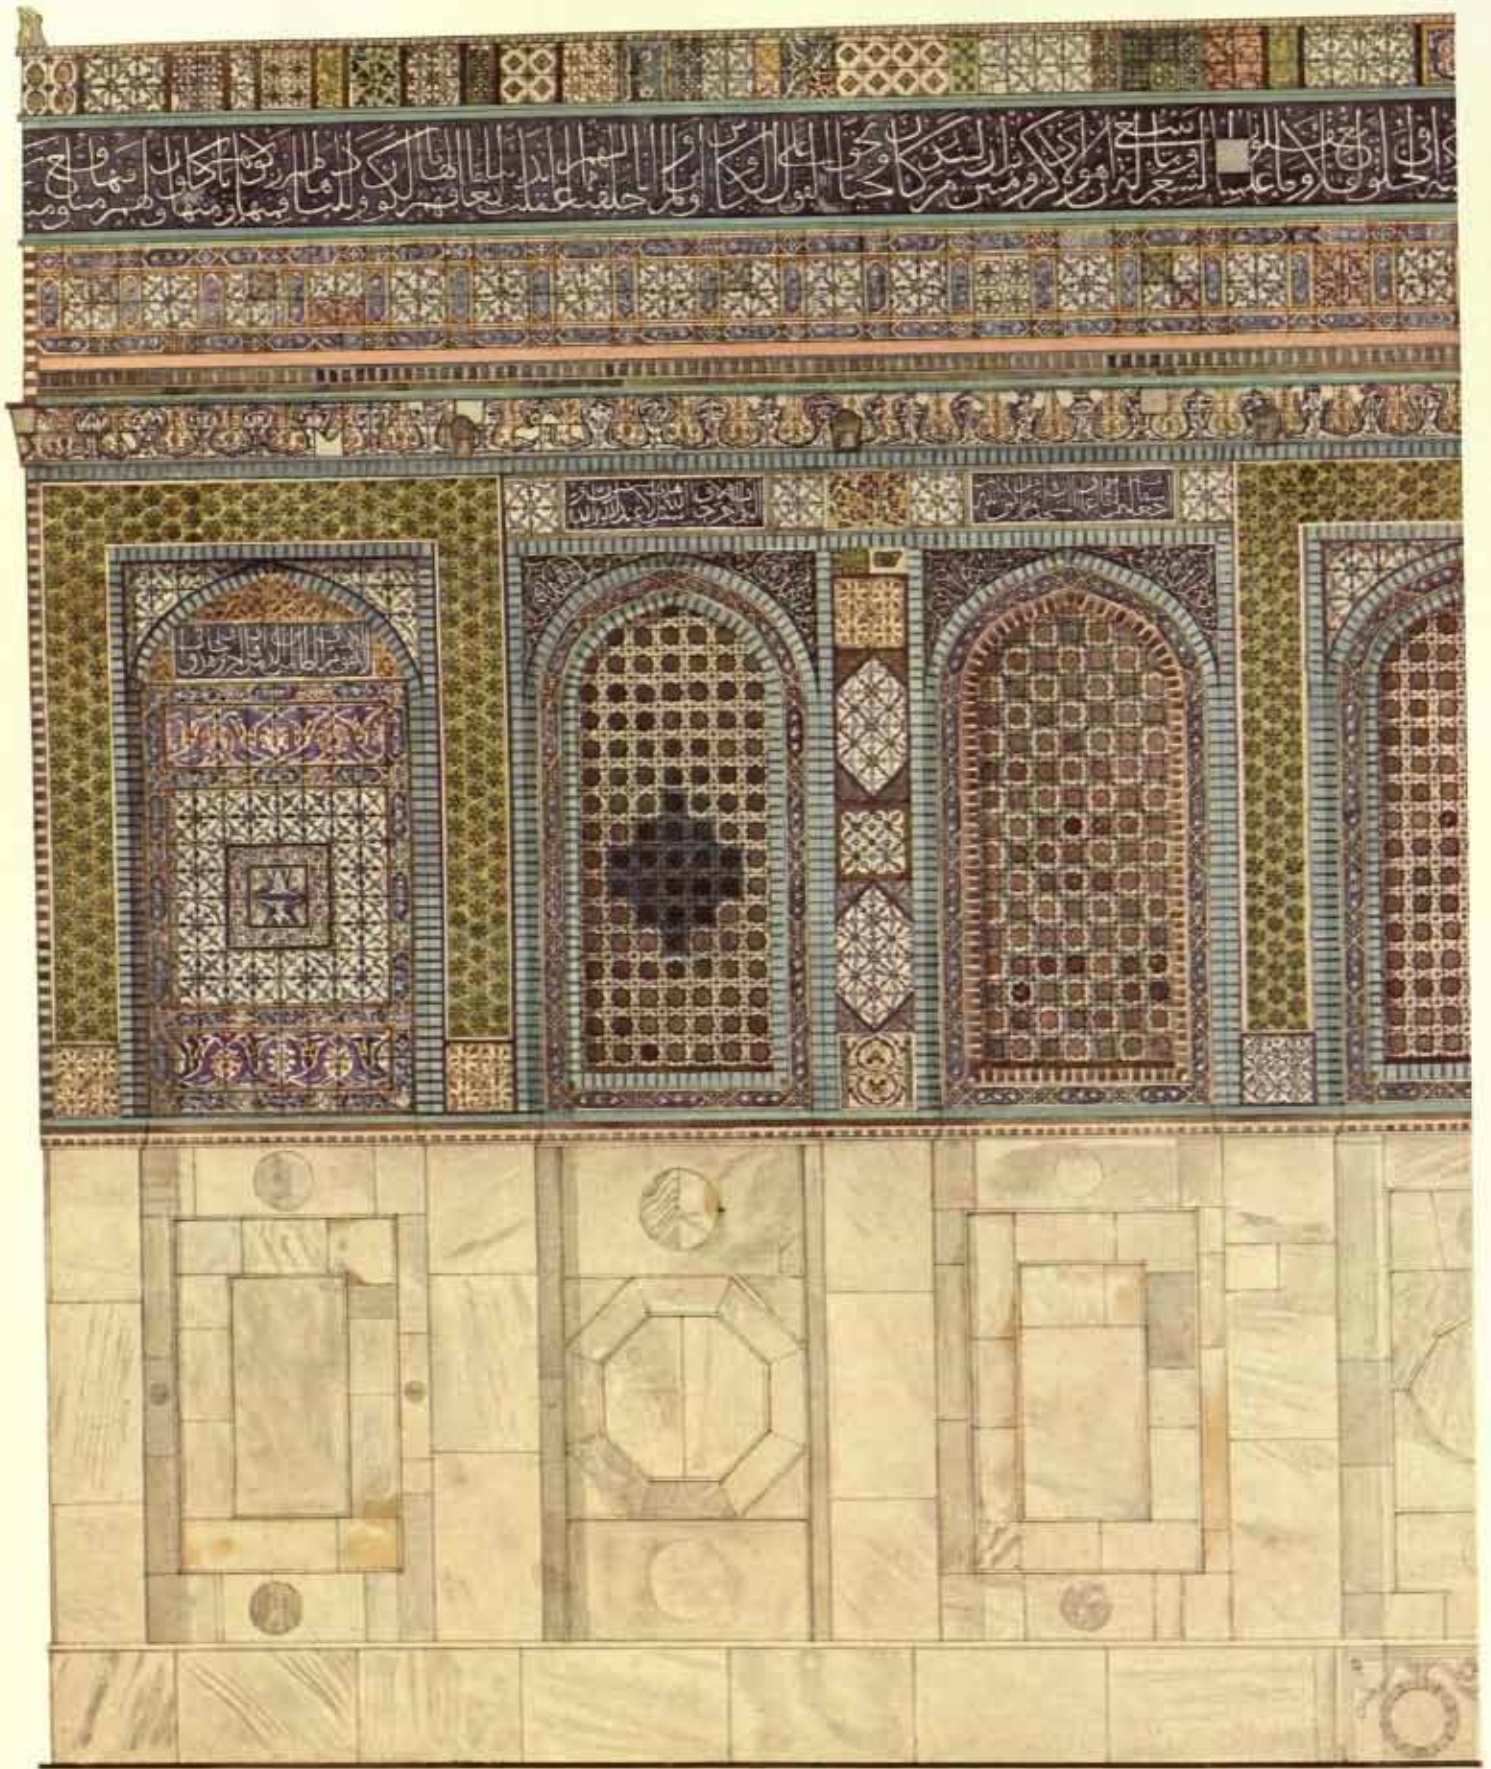
North-East face of Octagon. Three Bays showing present condition

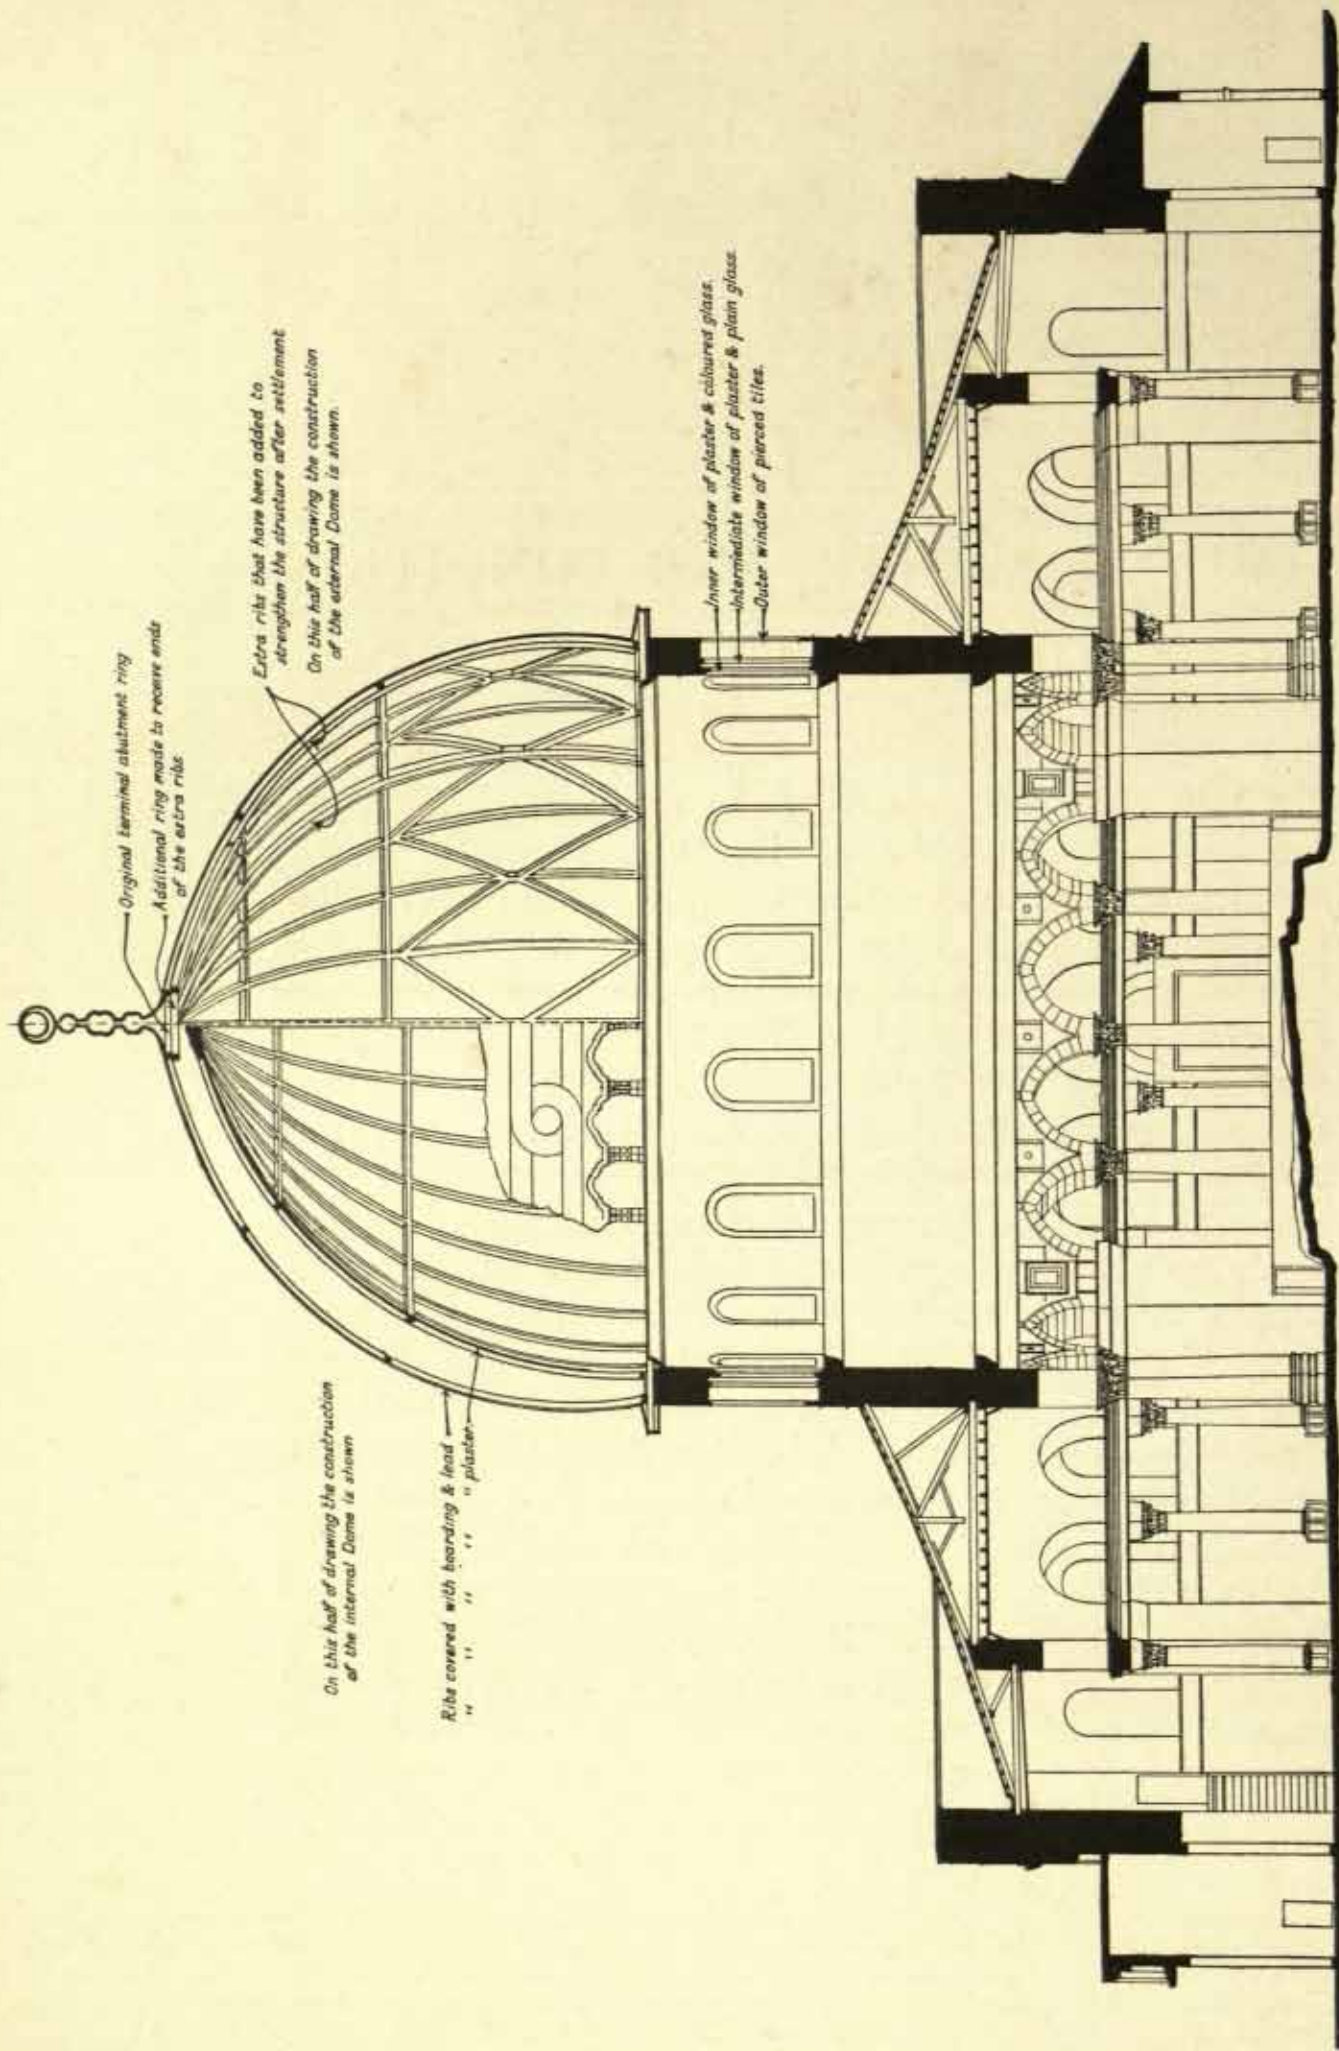
Fig.2. SECTION ON EAST & WEST AXIS

Diagram showing the relationship between the height (about 6.87 meters) of the main supports of the Drum & the following dimensions

- (I) Span of Dome = 6.87 x 3 (See A.A)
- (II) Height of Drum from floor = 6.87 x 3.
- (III) " " " " = $\sqrt{(6.87)^2 - (3.5 \times 6.87)^2}$
- (IV) " " " " outer octagon = $\sqrt{(2 \times 6.87)^2 - 6.87^2}$
- (V) " " " " to springing of arches of Drum windows = $\sqrt{(3 \times 6.87)^2 - (1.5 \times 6.87)^2}$

THE structure protecting the sacred Rock may, in a general manner, be described as consisting in a series of enclosures set one within the other (Figs. 1, 2). The innermost enclosure, immediately surrounding the Rock, is in the form of a cylinder of a height about equal to its diameter. This cylinder is covered by a dome, and its lower part is pierced with arches carried on piers and columns. Outside the cylinder are two successive octagonal enclosures of about half the height of the cylinder they surround. The first is in the form of an arched colonnade; and the second is a wall pierced with windows and with four entrances facing the cardinal points. The ceiling of the inner octagon is slightly higher than that of the outer octagon. The piers and columns that carry the cylindrical wall, and those belonging to the arcade between it and the outer wall, are disposed so as not to conceal one another, and so as to permit, from almost any position, a view right across the building (Figs. 3, 4, 6, 7). The columns are of coloured marbles with gilded capitals; the cylindrical wall and the arches of the intermediate colonnade are covered with mosaics forming conventional floral patterns of brown,

The ribs (Figs. 2 and 5) of the outer dome are in section about 21 centimetres square and spring from a wall-plate, into which they are housed, 21 centimetres wide and 17 centimetres high. This wall-plate is laid on the outer edge of the drum wall and is composed of pieces scarfed together and forming a continuous circular chain. The ribs of the inner dome are in section from 18 to 20 centimetres square. Each rib springs from its own wall-plate laid transversely across the wall, radiating from the centre of the drum and passing under the wall-plate of the outer dome. These wall-plates are in section 21 centimetres square, and in length they measure a good deal more than the width of the wall they traverse, projecting beyond the face of the wall on the inside by about 35 centimetres and on the outside by 85 centimetres. On the inside their ends provide support for the stucco cornice that crowns the drum wall, and on the outside they carry the outer cornice which divides the drum from the dome. Between the wall-plate of the outer dome and the feet of the ribs of the inner dome are short straining timbers 12 centimetres square in section, two to each inner rib to which they are halved, and between each inner rib is a straining-piece of similar section. Each dome has thirty-two ribs. In the outer dome every eighth rib is doubled by having under it a second rib of the same size. The ribs of the outer dome meet at their summit round a circular plate; those of the inner dome no doubt meet in the same manner, though the ring is not visible, being covered with boarding. Each dome is built in three sections one above the other and divided from one another by two horizontal plates. The ribs of each section are curved like those of a wooden ship; they are not cut to the curve required but bent. Where serious shakes exist in the timbers iron bands are used to prevent the shakes from spreading. The timbers used are of oak, cedar, and pine of a kind locally known as

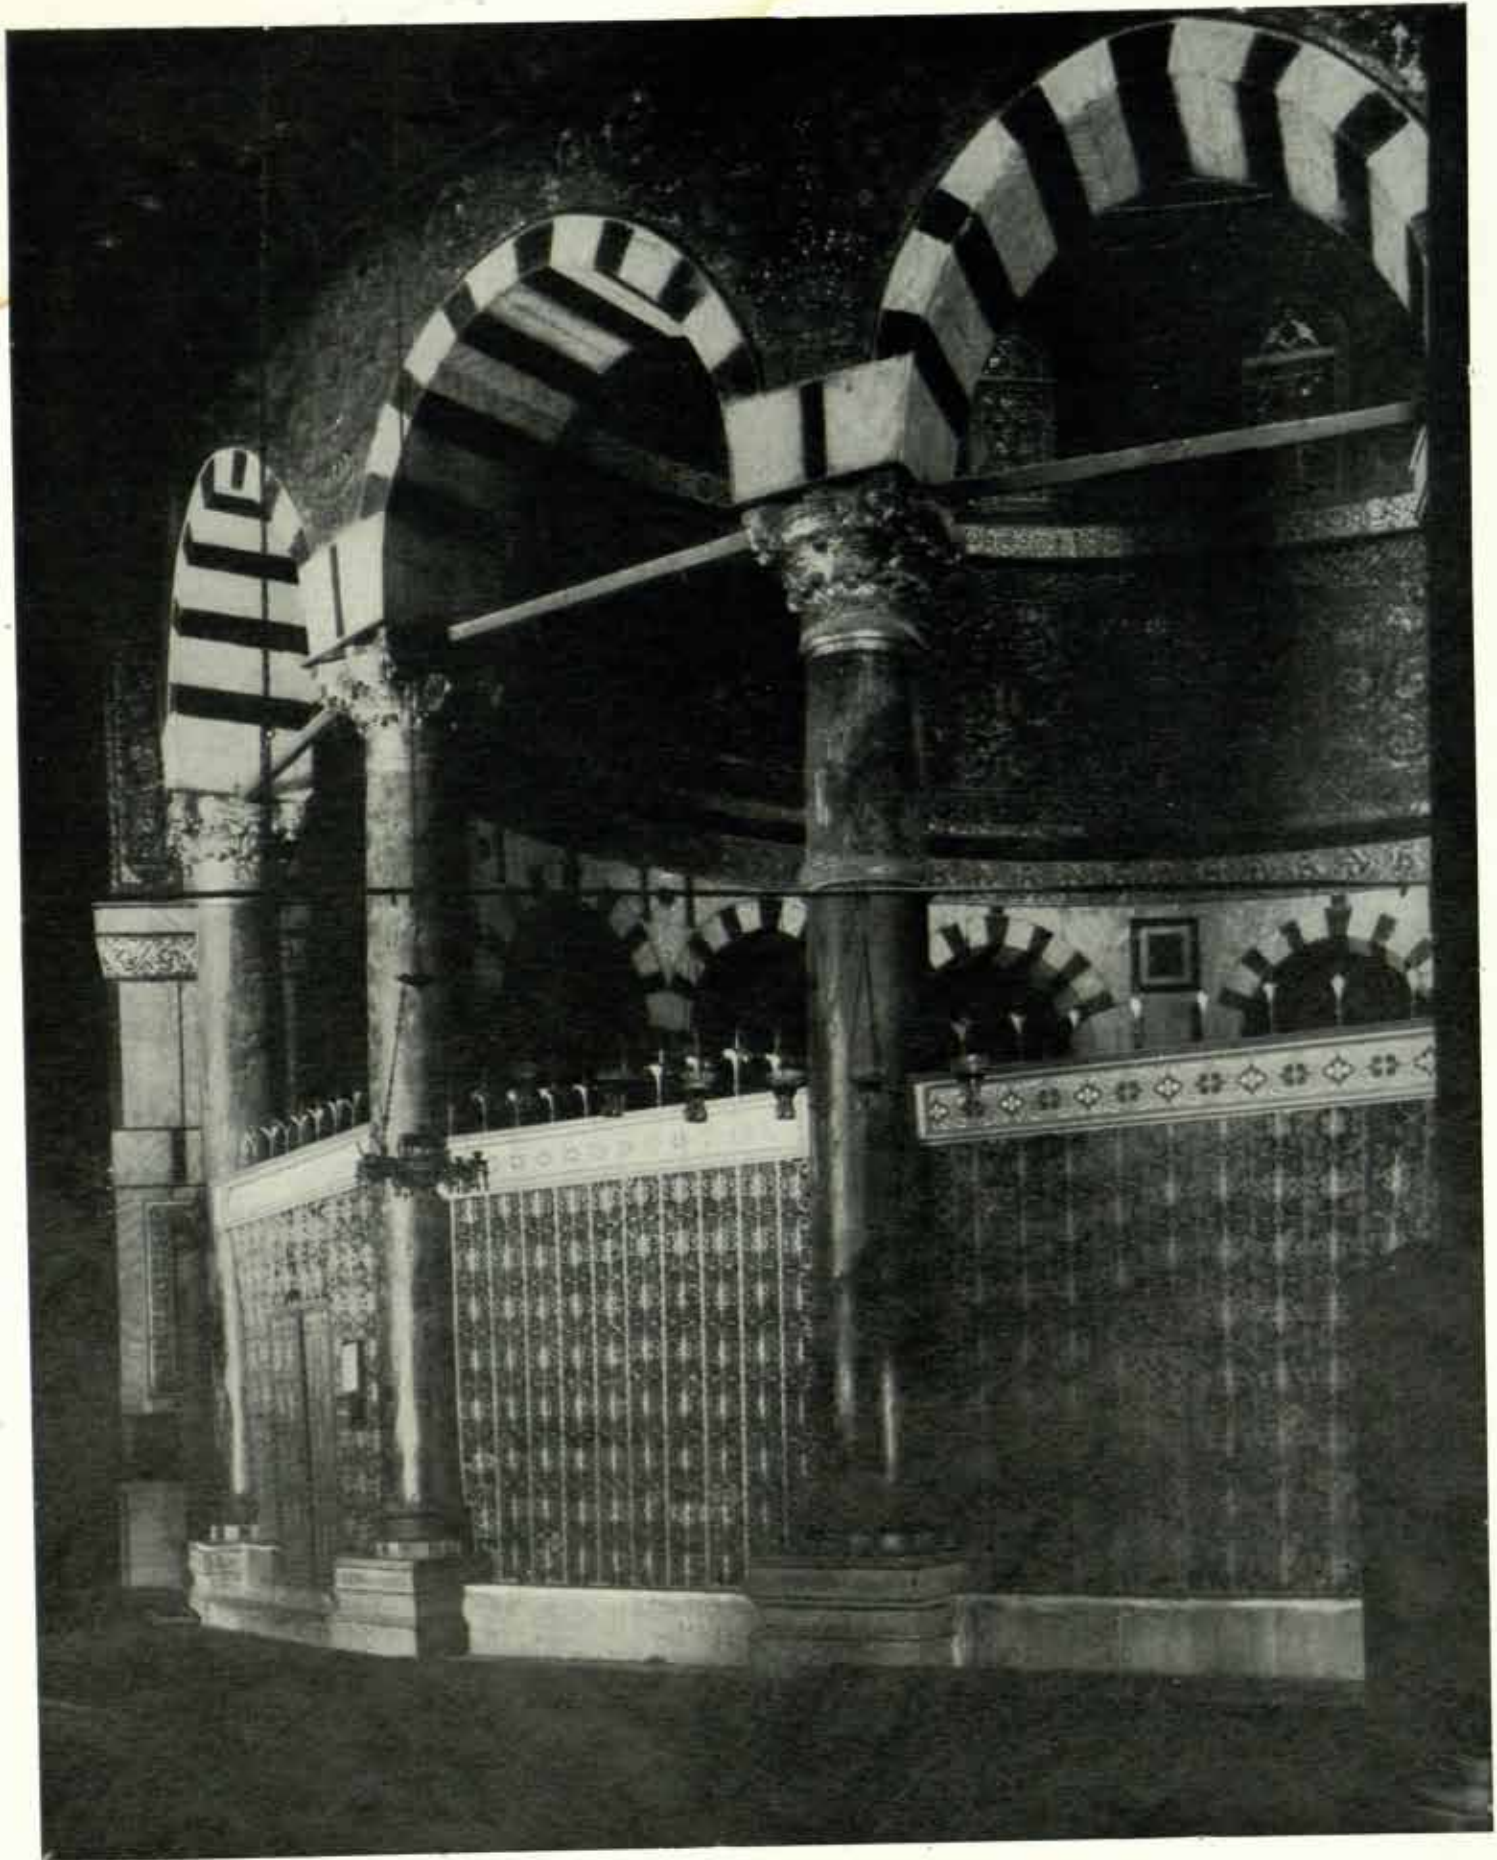
Fig. 3. A view of the columns and piers supporting the drum

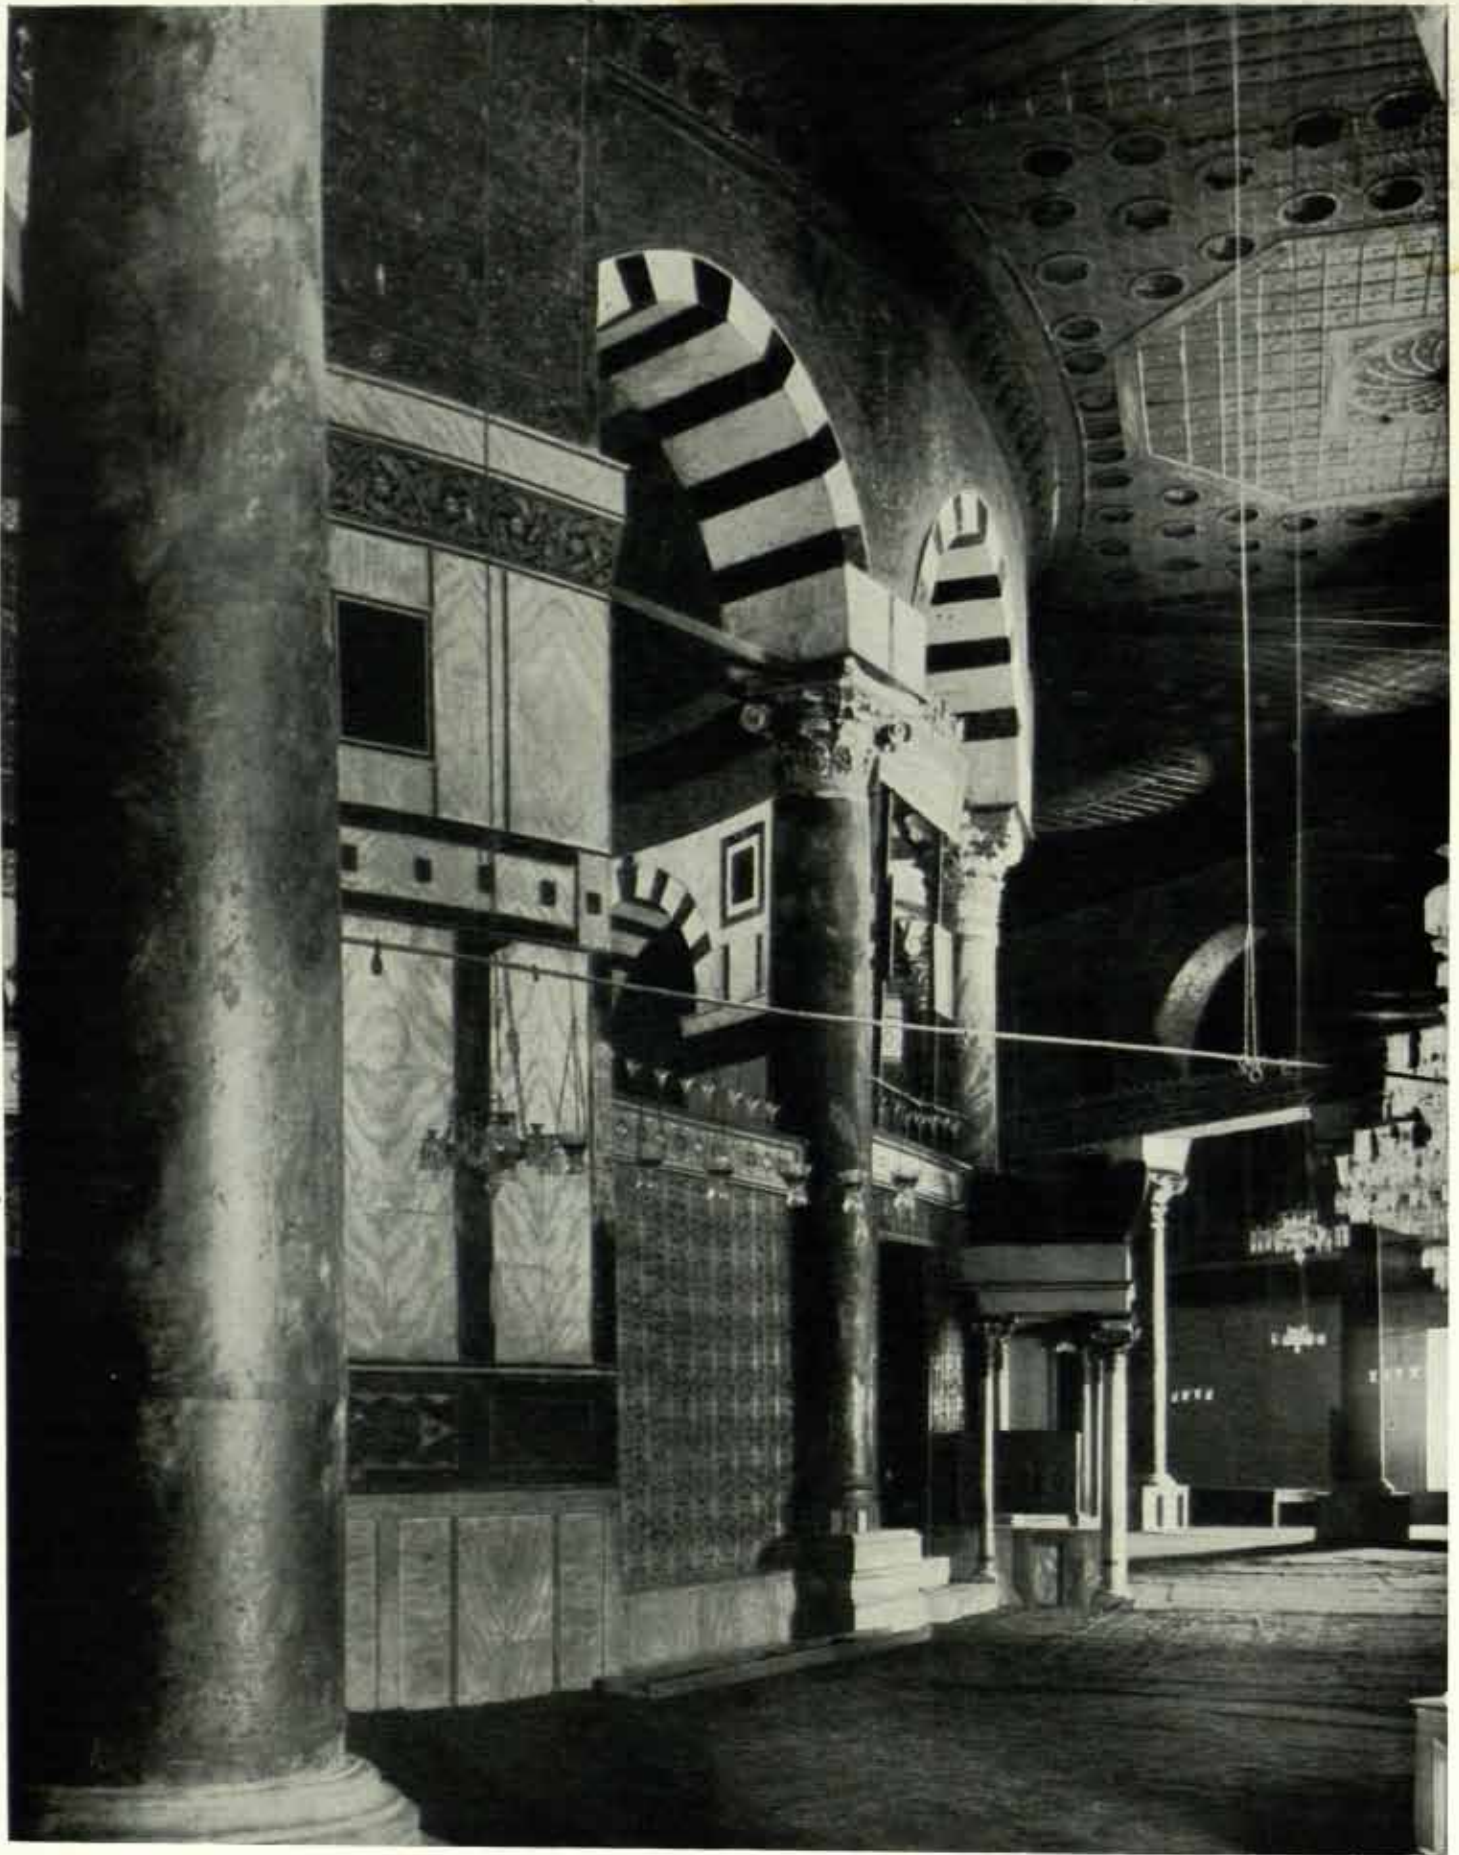
Fig. 4. A view of the columns and piers carrying the drum and, in the distance, of the arched colonnade between the outer wall and the drum supports

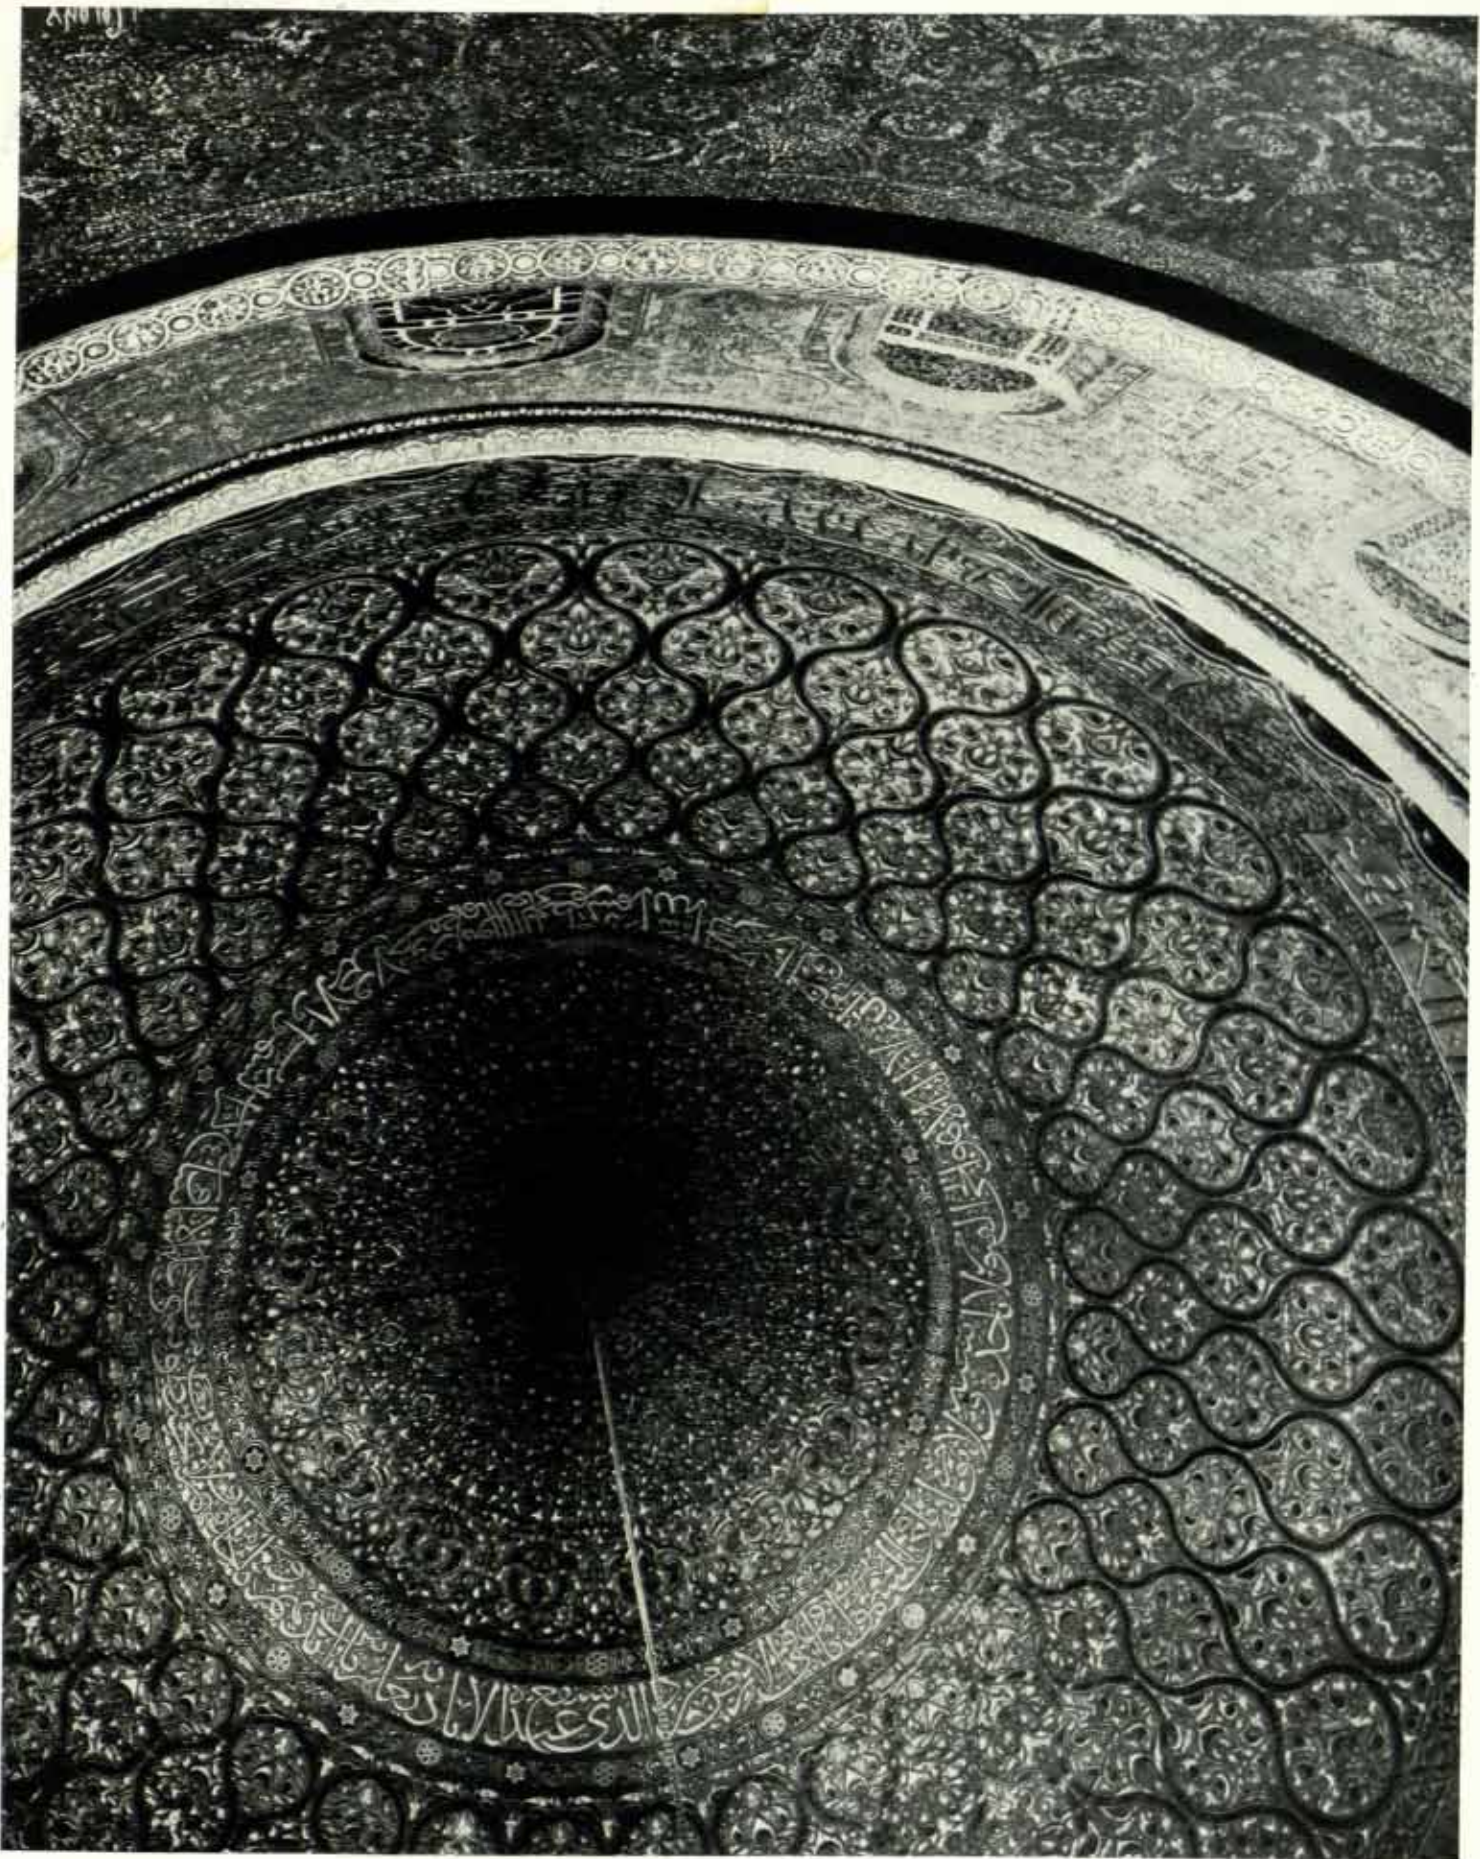
Fig. 8. Interior of the Dome showing the ornament of gilded and painted plaster work

black, blue, and green, and mother-of-pearl, set upon a gold background; the dome (Figs. 8, 9) is decorated with painted and gilded arabesques and inscriptions; marble covers the walls of the outer octagon and of the piers; and the window-openings are filled with coloured glass. An astonishingly rich and varied effect of structure, of ornament, and of light is thus produced. Looking across the building from one side to the other, the great swell of the cylindrical wall or drum is seen through an arch in the foreground. The many columns that carry the drum, together with those that are seen beyond and to the right hand and to the left, with their arches and their lines of gilded cornice, produce a crowded complex of structural forms that gives, by contrast, an appearance of impressive spaciousness to the area enclosed by the drum and, consequently, of great size to the dome, although the dome is, in comparison with other famous domes, but of modest span. Externally also the dome dominates (Fig. 14). But here the relationship between the dome and the enclosing octagon and the value given by the one to the other, is not so obvious as internally; and, though the building is, outside, less impressive than inside, yet its surface decoration—the lower part in marble and the upper part in Persian tiles—must, at one time, have been hardly less brilliant than that of the interior.

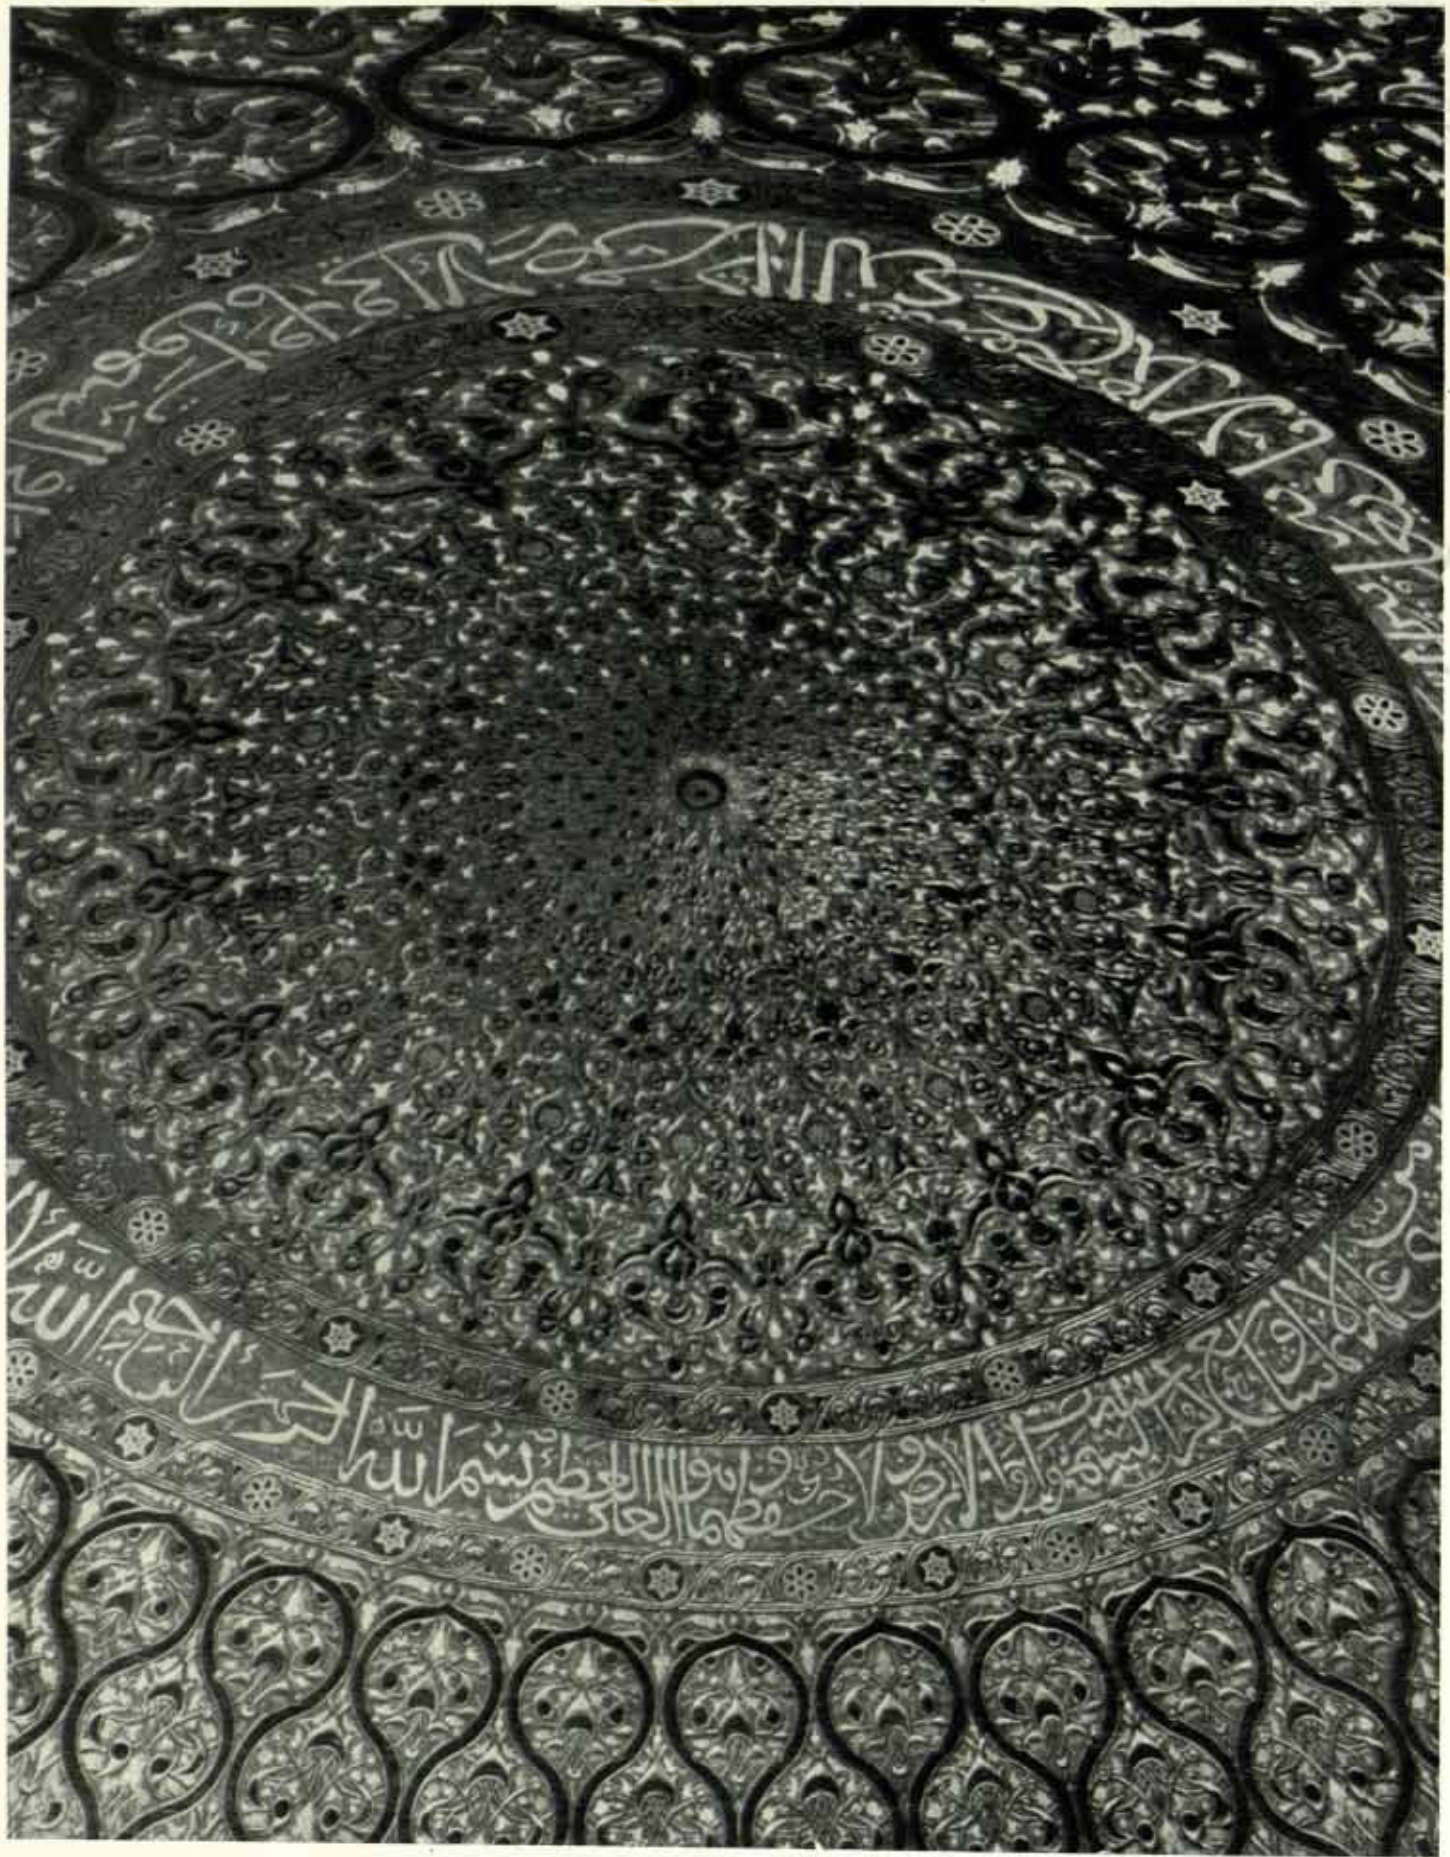
Fig. 9. A view of the Dome showing the decoration of its upper part

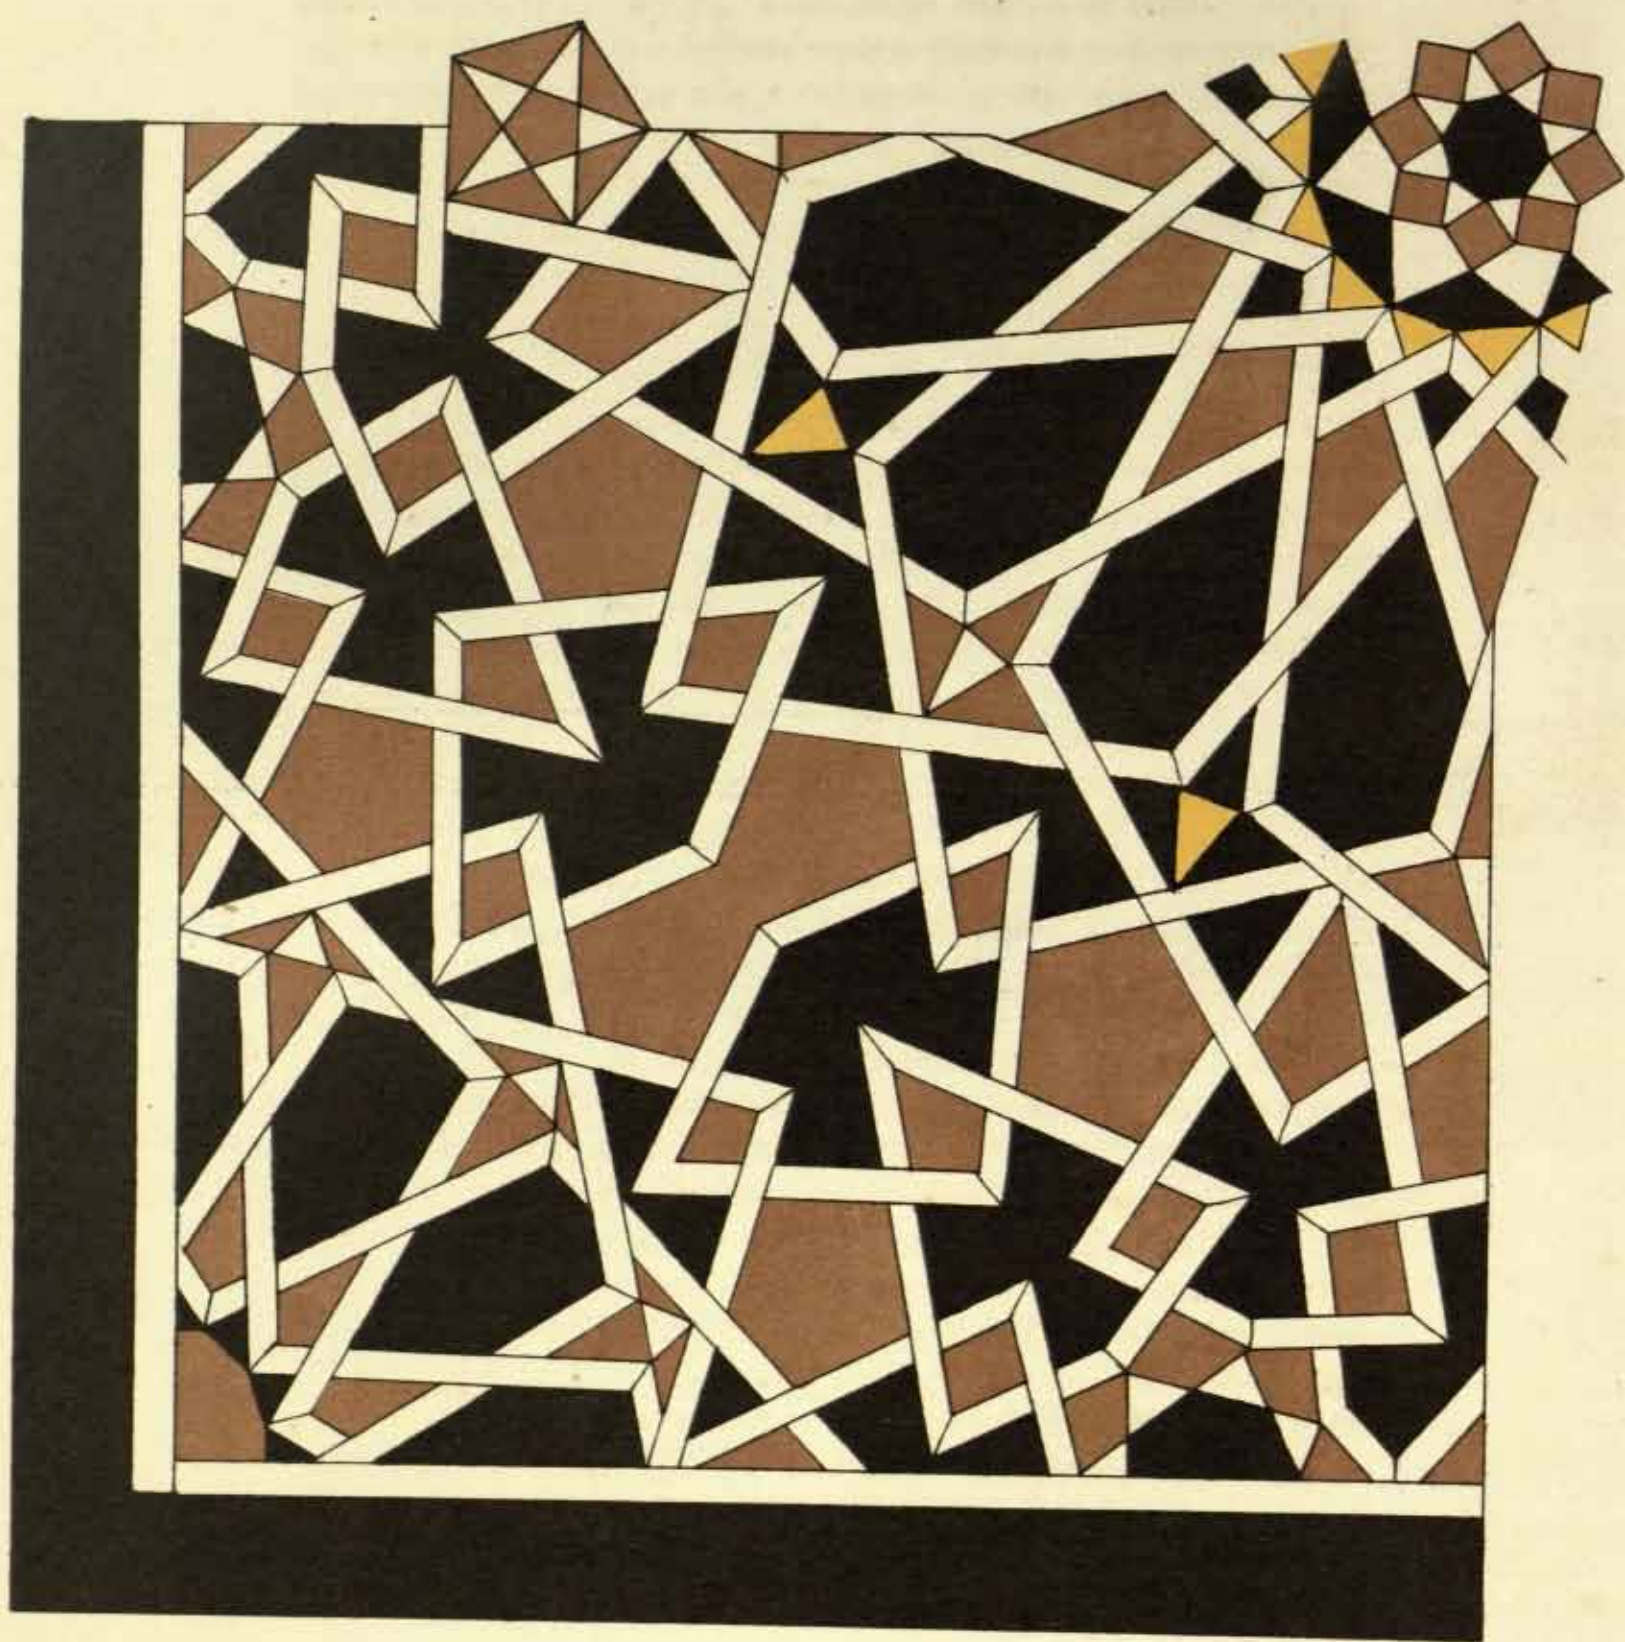
Fig. 11. One quarter of a tessellated pavement opposite the southern door

Scale 1:7.5
